Case Study

Preventing Air Line Freezing in a Food Packaging Facility

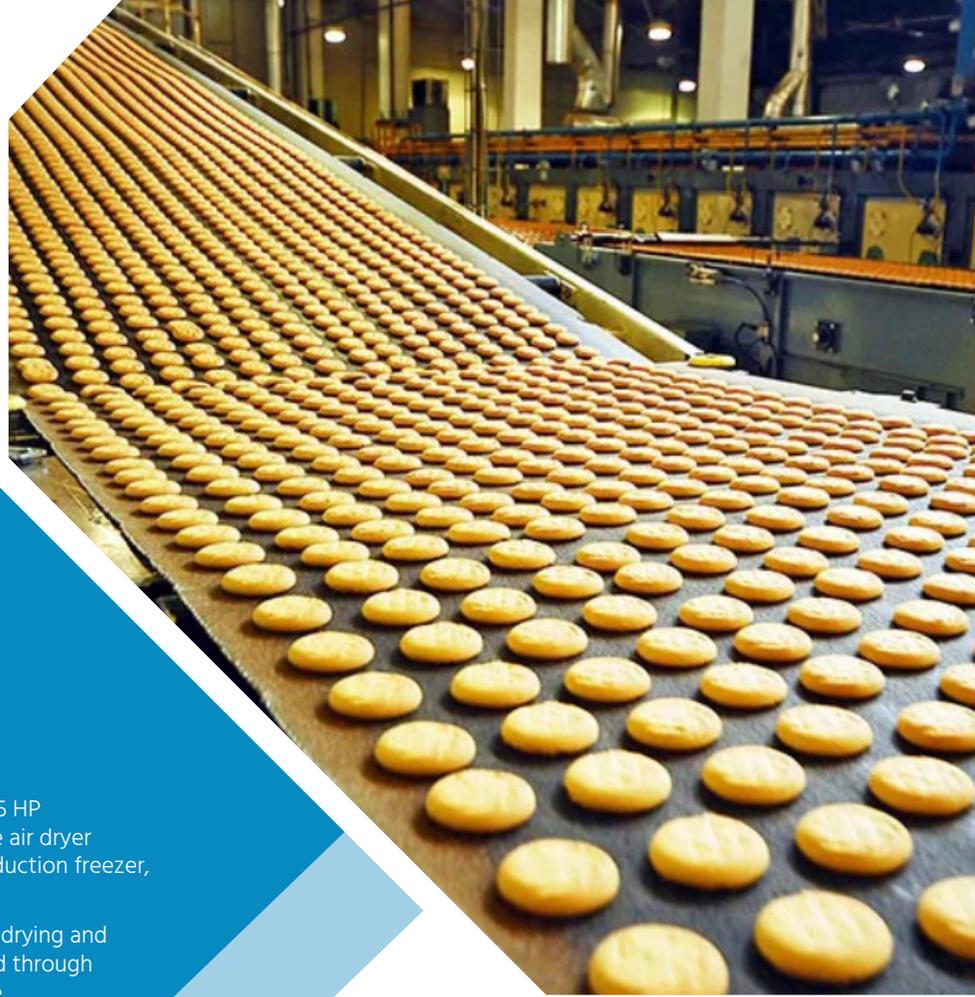
A major Canadian salad packaging facility operating a 15 HP Sullair compressor and a Nano twin-tower regenerative air dryer was still experiencing water and line freezing in its production freezer, where the temperature reaches -28°F .

Even though the main compressor room had adequate drying and filtration, moisture was re-introduced as the air traveled through long piping runs and cooled rapidly before reaching the freezer.

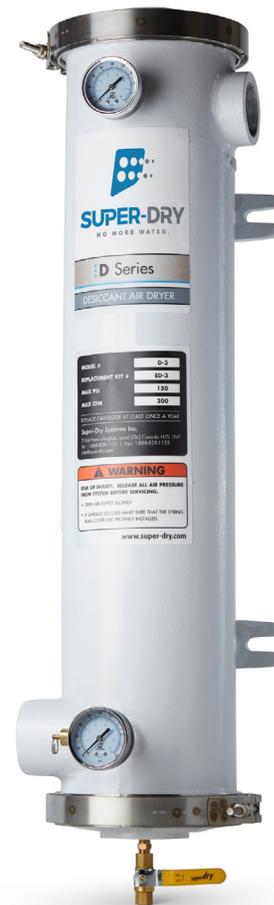
Added System: Super-Dry Model D3 Desiccant Air Dryer

Application: Point-of-use air drying for freezer lines (-28°F)

Super-Dry recommended installing a Model D3 Desiccant Air Dryer directly at the point where the air enters the freezer area.

- ✓ Positioned at the end of the air line, the D3 removes residual moisture that the central system cannot capture after temperature drops.
- ✓ Compact and low-maintenance, the D3 easily fits near the freezer entrance without additional power or drains.
- ✓ Using desiccant drying, it ensures a consistently low dew point, keeping compressed air perfectly dry before entering the freezing environment.
