Case Study

Eliminating Sandblasting Downtime in Minnesota

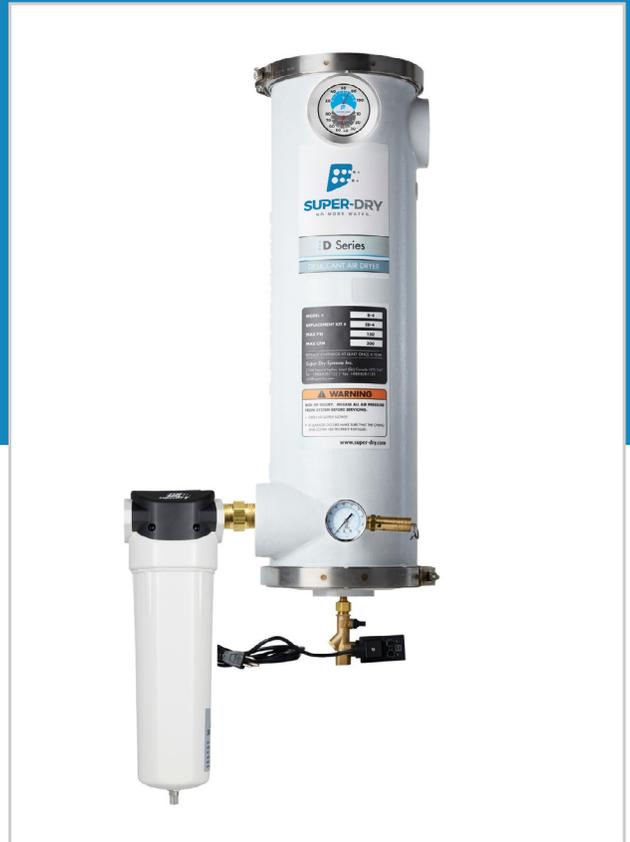
Super-Dry D4 Desiccant Air Dryer

Removes water vapor to deliver ultra-dry compressed air downstream.

Super-Dry FSD-515-W Water Separator

Captures and removes bulk liquid water before it reaches the air dryer.
